Analysis of a Clinically Failed, Mechanically Intact, Hemi-Toe Implant

Abstract - In this case study a clinically failed, mechanically intact, hemi-toe device was investigated. The clinical indication of the failure constitutes radiolucent line indicating loosening of the implant and possible interactions among the bone-implant initiated by osteolysis may become a factor, producing pain, inflammatory reactions, deformity and discomfort. The patient file was not available to determine these parameters. The device was titanium coated, Cobalt Chromium alloy used for making hemi-toe. Degeneration of hemi implant was due to spalling of the coating from the surface, causing loosening of stem from bone. However, pre-removal X-ray films were not available to confirm. Mechanism by which the clinical failure occurred likely due to lack of bony adhesion or other clinical reasons. Surface topographical features were documented using optical microscope. A method to classify various area of the articulating surface was proposed in this study that shows the anterior contacts were more damaging than the other areas where deeper scratches, pits and some debris were present. There is a need to conv

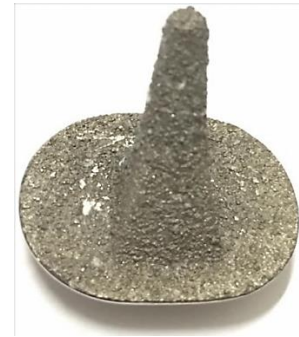
Scratches were visible on the shiny articulating surface of hemi-cap. There are also visible wear, spalling off of coating from the stem of the implant, Fig. 3. Visible sediments (white colored) on the stem and edges between stem and hemi-cap were notable. Since the stem was only presented for this investigation and liner was not available, the results and

Figure 3. Wear and spalling of coating materials from surface.

The microscopy revealed that the anterior and middle section (Fig. 5-7) of the hemi experienced more scratches, wear and some debris deposition resulting from polymer debris and adhering to the surface may have occurred (3). Since the coating spalled (Fig. 3, 8) it may be possible that the device may have become loose. This loosening may have compromised the bony ingrowth and fixation of the device in the intramedullary canal of the bone. Since patient details are not available, it will not be possible to comment the time that this device was successful *in vivo*. The device maintained mechanical integrity though failed clinically because such fixations cause pain, deformity, infection and other potential problems (4).

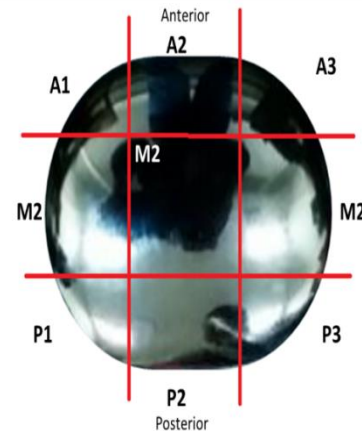
Figure 4. Nine segments marked on the articulating surface to assess damage.
